Horowhenua District Council Building SH1, Levin - Seismic Assessment

**New Council
Building
126-148 Oxford St,
Levin**

Detailed Seismic Assessment Report

Date: 20th June 2014

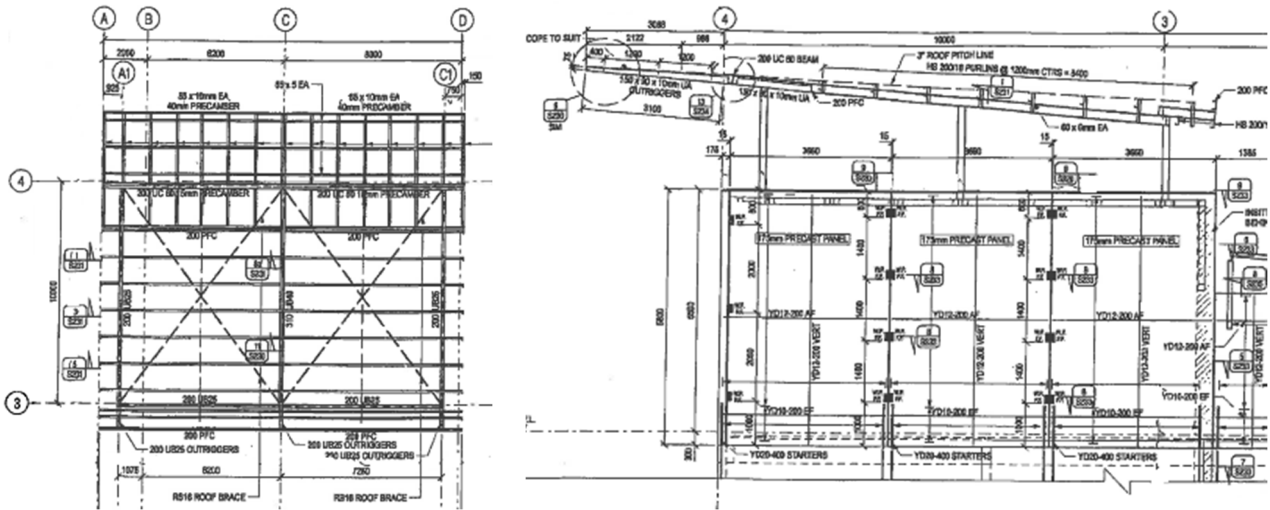
Figure 5: High level roof at the SW end of the HDC's New Council Building – Roof Plan and Elevation

At the SW end of the building, the high roof part is a flexible steel framed structure welded to the chords of the horizontal trusses at the top level of the precast panel returns.

The welded connections allow for rotation at the base of the posts which will increase the corresponding frame displacements.

The ULS drifts achieve a minimum 50%NBS in the NE-SW direction and are likely to cause damage to the cladding, roofing and internal fittings.

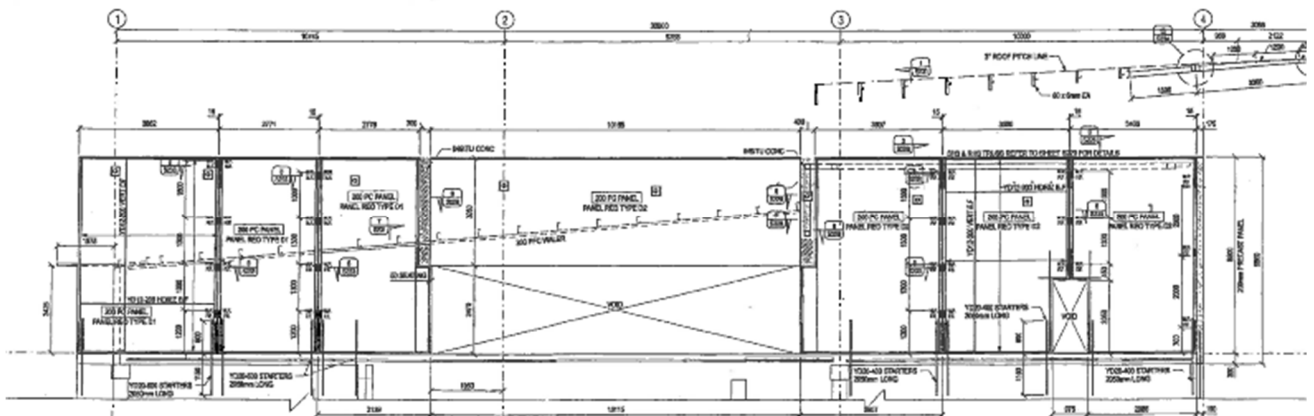
Figure 6: Elevation D of HDC's New Council Building – Precast Concrete Panel Walls

The wall system on Elevations D and E achieve a minimum rating of between 40% to 60% NBS in the NE–SW direction indicating an area of potential damage in a moderate earthquake event.

- The precast concrete panel walls are transversely restrained by whalers that are generally aligned with the lower roof angle. The whalers are tied to the panels through chemical anchors but they are not properly restrained to the lateral load system at their ends.
- The reinforcement provided for the in-situ stitch joints on both wall elevations is not consistent with the demands generated from the multiple load paths formed.
- The walls support the lower canopy roof part of the structure which itself appears to lack a diaphragm.
- The reduction of the panel thickness, at the locations of the beam-to-panel connection, along with the reduction in reinforcement indicate a highly stressed region that is potentially subject to local damage.

To summarise our main concerns are that these large and very heavy concrete spandrel panels suspended at height above the foyer do not have very robust connections and could become dislodged or lose support in a major earthquake.

These elements have the lowest structural element rating of 40% to 60% and govern the overall rating of the building. An average value of 50% has been used for reporting in the table 6 above.

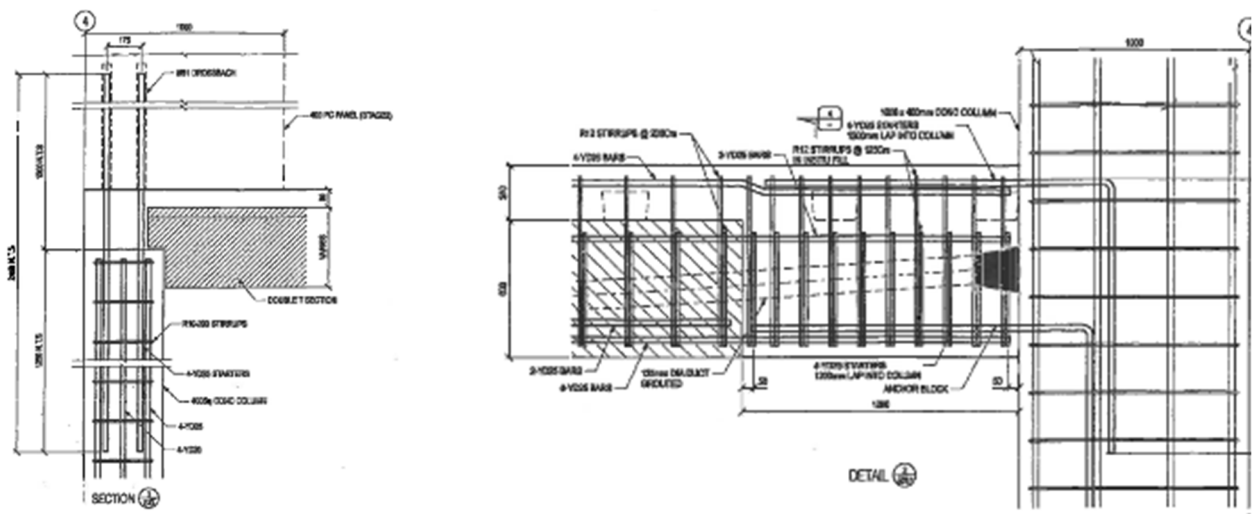
Figure 7: Gridline 4 – Starter bars at the columns' base and Beam-to-Column reinforcement detail

There are a number of issues with the detailing of the concrete columns along Grid 4 on the outside edge of the Mezzanine that will affect the performance of this frame.

- The starter bars provided at the base of columns on Gridline 4 are not able to develop the required moment connection.
- The columns themselves are not directly connected to the diaphragm at the Mezzanine Floor level due to the voids at the slab edge .
- The connection between the columns and the post-tensioned concrete beams to the columns terminates early within the column and the bars are bent down and not into the centre affecting the ability to transfer loads through the joint as a suitable concrete (strut and tie) mechanism cannot form.
- This does not appear consistent with the design intent for this element.

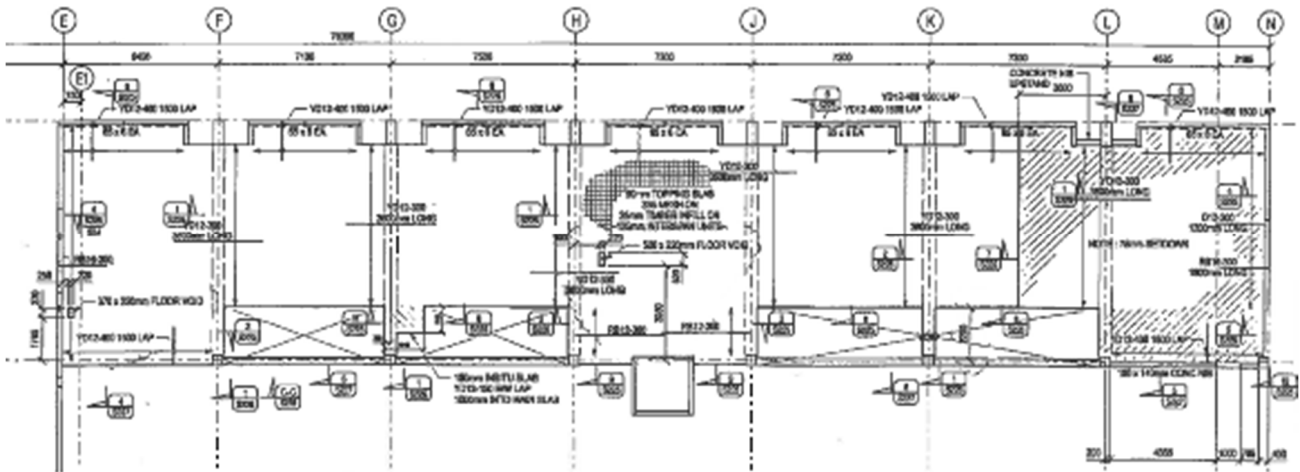
Figure 8: Mezzanine Floor level at the HDC's New Council Building

The slab is reinforced with a non-ductile 335 mesh and there are a number of openings at the slab edge adjacent to the connections to the main vertical structure which cause stress concentrations.

Non-ductile mesh has been proven to perform poorly in highly stresses diaphragms in the Christchurch Earthquakes and is no longer used in this type of construction.

Our assessment is that the slab will despite this will still be able to work as a diaphragm via a strut and tie mechanism however significant cracking and damage will occur and rupture of the mesh in the concrete slab is expected this damage will be amplified by openings at the slab edge.

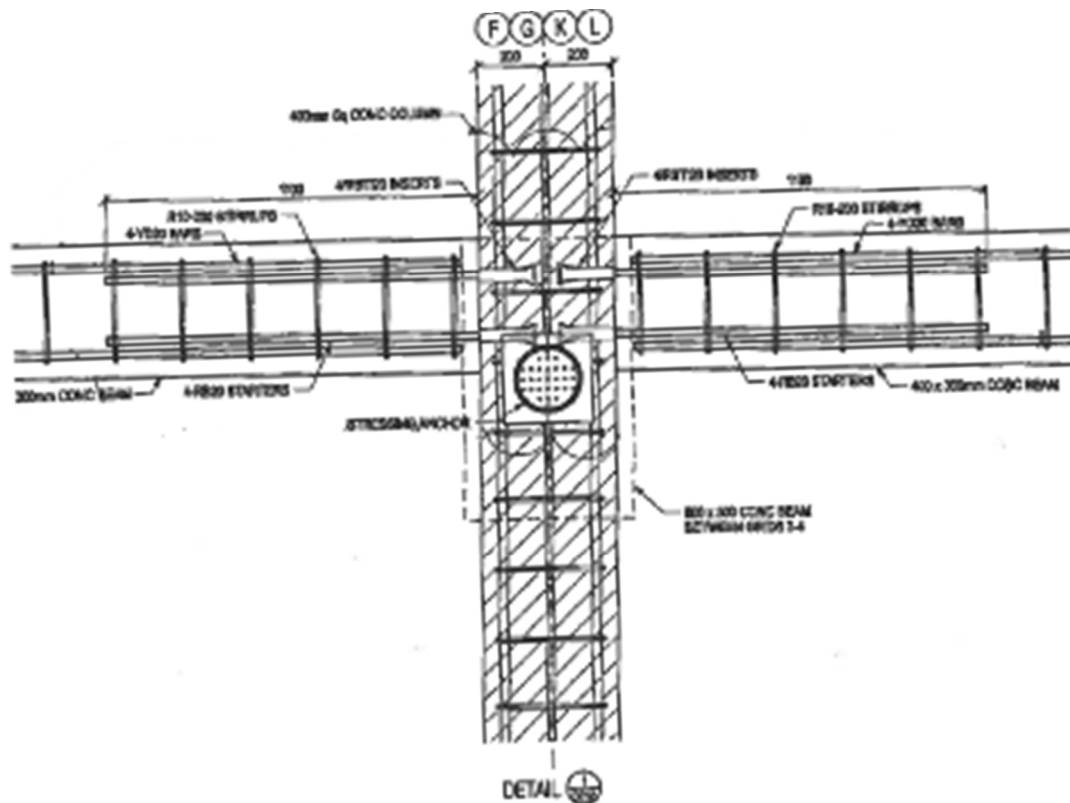
Figure 9: Beam-to-Column reinforcement detail.

The longitudinal reinforcing bars do not penetrate through the column and therefore no beam–column joint is formed and the joint has a very low displacement and force capability.

It is likely that a brittle failure mode such as vertical shear failure through the column or premature fracture of the longitudinal bars at the connection is likely to occur if the frames are displace horizontally and the beams will eventually lose their support.

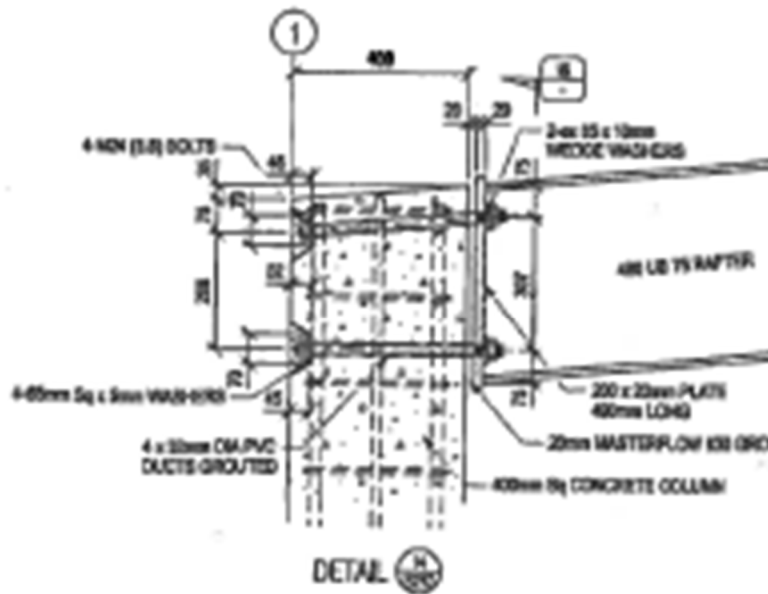
Figure 10: Beam-to-Column 460UB75 connection detail

The connection detail of the lower roof rafters to the columns on Gridline 1 may also lead to a load distribution that differs from that intended in the original design of the elements.

The top group of bolts is placed at 75mm from the columns edge and therefore it is of question whether the full moment capacity of the connection can be achieved.
