MB/W160204

Horowhenua District Council
126 Oxford Street
Levin

RE: Report on the Structural Behavior of Existing Building at 126-148 Oxford Street, Levin

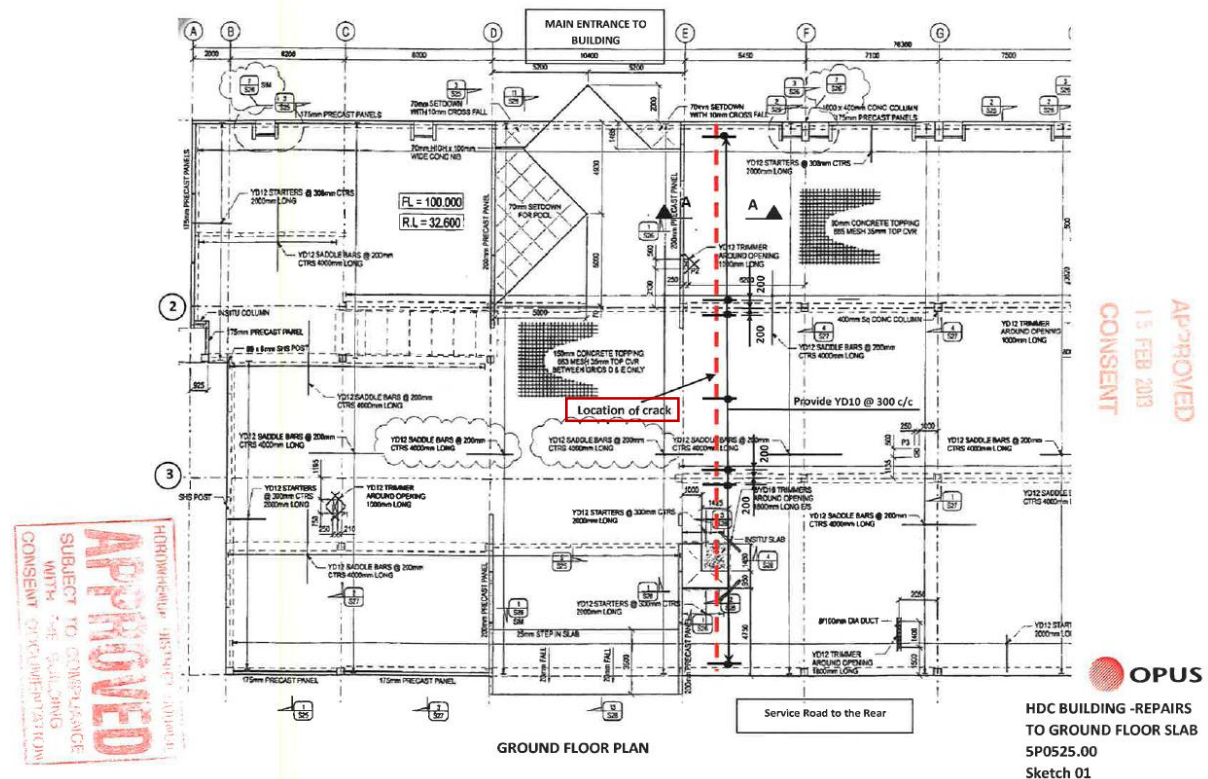
Fig.2: Location of crack on ground floor slab

The most severe crack was observed on the ground floor slab, between grid lines E and F, as shown on Figure 2 below.

The crack occurred at the joint between two adjacent floor panels and runs in the transverse direction of the building. It developed through the full depth of the concrete topping. The retrofitting is expected to have restored the full capacity of the diaphragm at this location.

The crack seems to be a result of concrete shrinkage as explained above. It was reported that light could be seen through the crack. This is an indication of the development of uniform axial tension and strains that exceeded the tolerance of the concrete topping. If the cause of the crack was a structural action of a different nature (e.g. differential settlement of the foundation) the crack would be categorized as a bending crack with an opening at the top face and close at the bottom (or reversed) but in any case light should not pass through the crack.

It may be expected that similar cracks may have developed or will develop at other locations. Ground shaking during an earthquake could expose these cracks. However, the configuration of the structure does not create a collapse mechanism with inelastic rotations at the locations of the observed cracks.

However, it is recommended to fill the cracks with appropriate products to avoid future corrosion.
