Reference Number: 2023/995

### Response - Official Information Request

## **HDC – Foxton Memorial Hall - Initial Seismic Review.**

# **Foxton Memorial Hall Concept Seismic Retrofit Scheme**

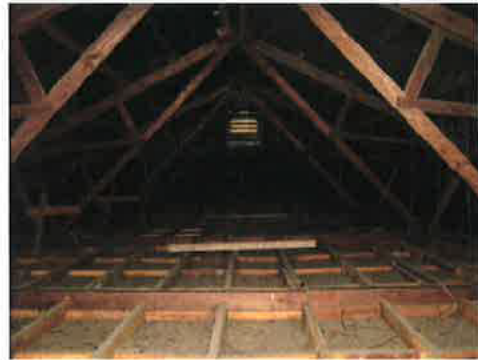
Fig 5. Roof over Hall.

The calculated seismic rating for this building is <33 percentage of New Building Standard (%NBS) due to a lack of any adequate bracing system provided within the roof or ceiling. A quantitative assessment of the building elements was undertaken to examine in more detail the potential overall seismic rating which could be achieved for the other elements of the building, assuming the bracing system provided in the ceiling/roof was of sufficient strength to transmit the lateral forces to the relevant shear walls (i.e. strengthening had been provided). This concluded that the building would still achieve a %NBS < 33% due to in-plane shear failure of the URM walls in the transverse direction and out-of-plane failure on a number of URM panels in Main Hall (i.e. the panels with high level windows).

Investigate the practicality of providing either steel bracing or plywood diaphragms to the roof/ceiling of the Main Hall and the foyer/office area.

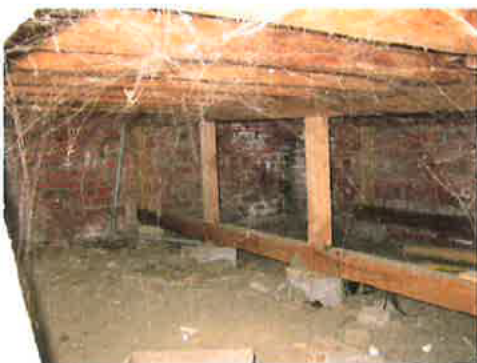
Fig 8. External walls under stage area.

Generally the visible parts of the structure would appear to be in good condition for the age of the building with no obvious signs of movement or distress identified. However due to a recent refurbishment and redecoration having been undertaken on the building any existing cracking/movement would likely have been filled and painted over, both internally (plastered finish) and externally (rendered finish).

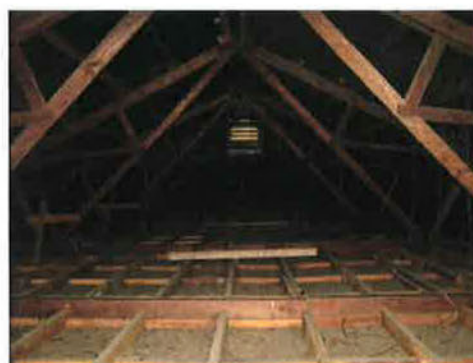
Fig 5. Roof over Hall.

The calculated seismic rating for this building is <33 percentage of New Building Standard (%NBS) due to a lack of any adequate bracing system provided within the roof or ceiling.

***The provision of a bracing system in the ceiling/roof.***

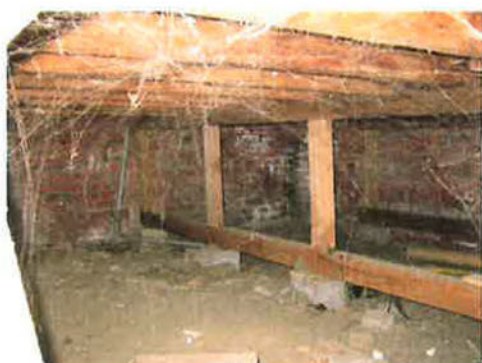
Fig 8. External walls under stage area.

Generally the visible parts of the structure would appear to be in good condition for the age of the building with no obvious signs of movement or distress identified. However due to a recent refurbishment and redecoration having been undertaken on the building any existing cracking/movement would likely have been filled and painted over, both internally (plastered finish) and externally (rendered finish).
