# Resource Consent Application - Form 9

**Proposed Works Oxford Street Plane Trees**

Removal of all Plane trees from Queen Street West Northward to Denton Street with grinding out stumps and reinstatement of tarmac footpaths and roads.

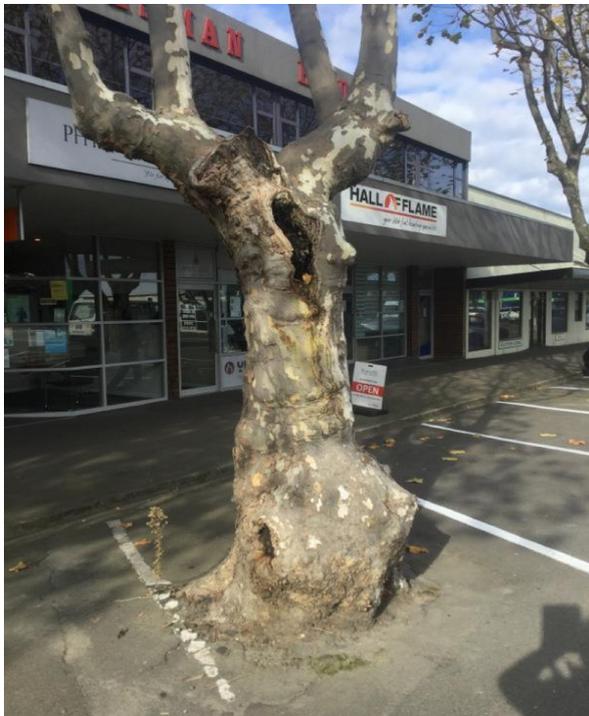
**Image 1:** Tree situated in road showing cavities and asphalt uplift.

Many of the trees are located in the road leading to potential trips as the roots uplift tarmac as per Image 1 adjacent. There is also a risk of vehicles striking the stems whilst parking.

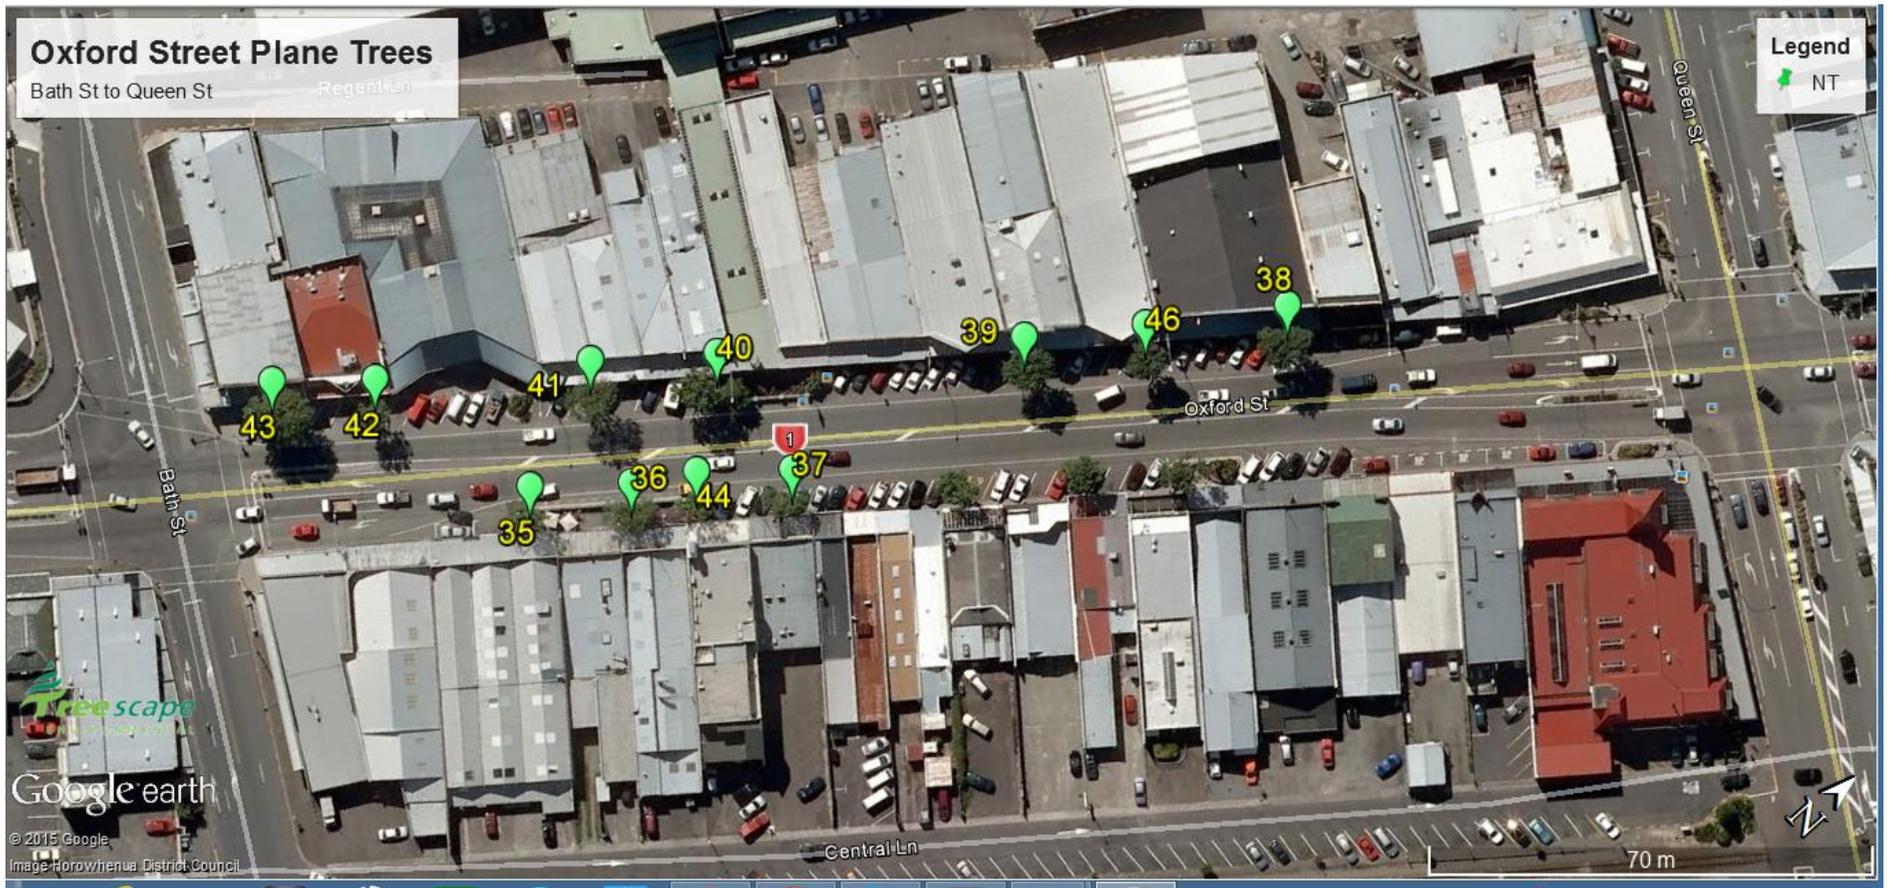
Figure 2- Notable Planetree locations.

- 2.6. Field assessment attributes of the Planetrees, as numbered in the District Plan Notable Tree Schedule, are shown in Table 1. The assessment criteria used in Table 1 can be found in Appendix C of this report.

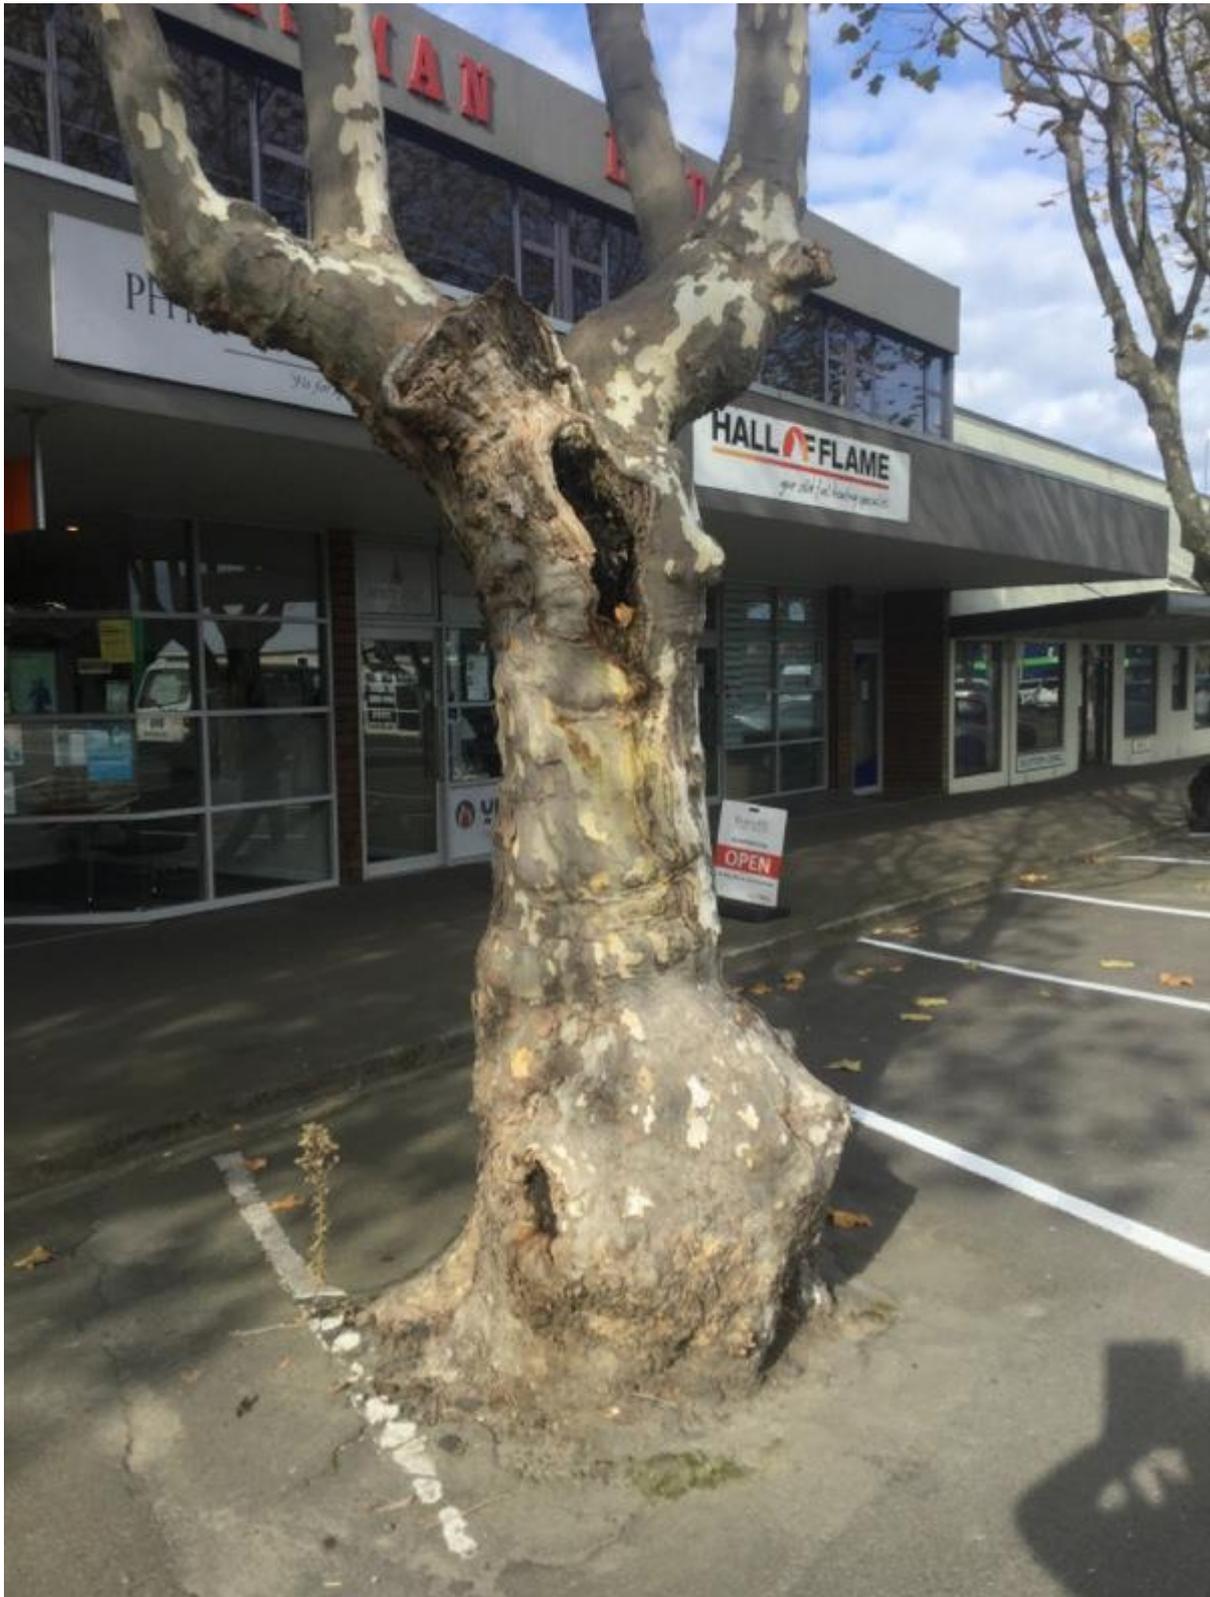
Photograph 1 – Tree 7

6	Platanus x acerfolia	11.4	1460	5.9	Lapsed Pollard	Fair	Mature	HDC	Yes	Tree root zone 100% hard surface
7	Platanus x acerfolia	9.7	1650	6.1	Lapsed Pollard	Fair	Mature	HDC	No	Tree root zone 100% hard surface Large swelling on NW base of stem, with cavity on its N side Large open cavity at 2m spreading from old pollard wound Hammer soundings indicate internal stem decay on NW side from ground level to open cavity below pollard cut Tree should be considered for proactive removal and replacement planting
8	Platanus x acerfolia	12	1310	7	Lapsed Pollard	Fair	Mature	HDC	Yes	Tree root zone 100% hard surface Small cavity evident at lower pollard points Tree has regrown full crown
9	Platanus x acerfolia	12.5	1670	6.4	Lapsed Pollard	Fair	Mature	HDC	Yes	Tree root zone 100% hard surface Small cavities evident at lower pollard points
