Response - Official Information Request

Water quality improvement in the Waiwiri catchment through strategic establishment of native ecosystems with bioactive properties used at a land treatment site

Final report – January 2023

Report number: FW23002

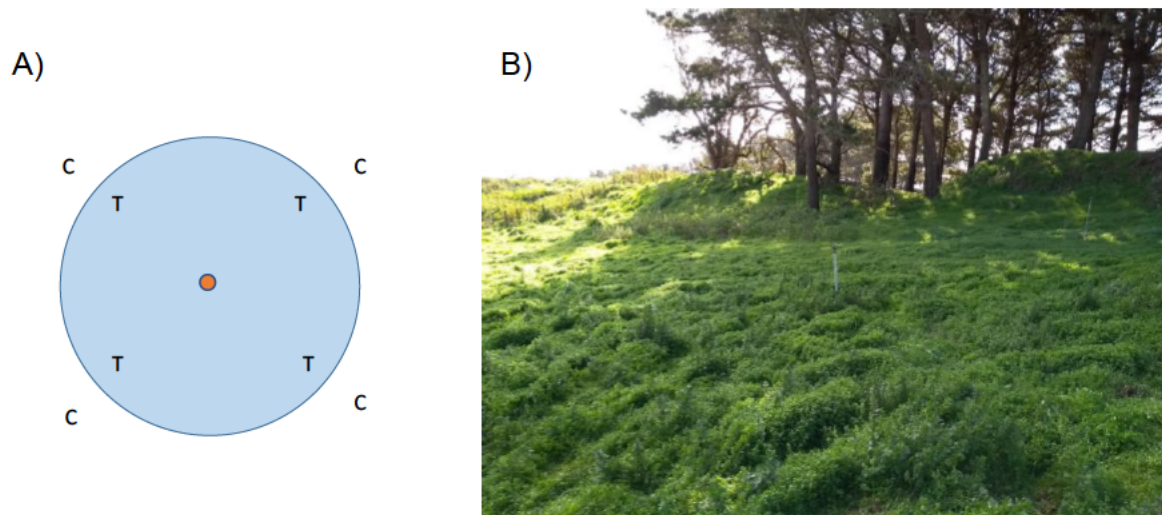
Figure 1 A) Experimental design of the preliminary trial, T: irrigated plants within the reach of the sprinkler, C: non-irrigated control plants; B) Photo of the sprinkler with surrounding plants.

Aerial parts of plants were cut and carried to the laboratory in paper bags. Plants in the irrigated treatment were separated between the inner and outer circles. Any signs of stress and disease on the leaves were observed and written down, and plants were oven-dried at 35 °C for 15 days. When plants were dried, leaves were separated from stems and weighted separately. For the analysis of results, only mānuka and kānuka had enough number of plants in the inner and outer irrigated circles as to analyse the results separately. The rest results for the rest of species were just analysed for irrigated and non-irrigated control treatments.

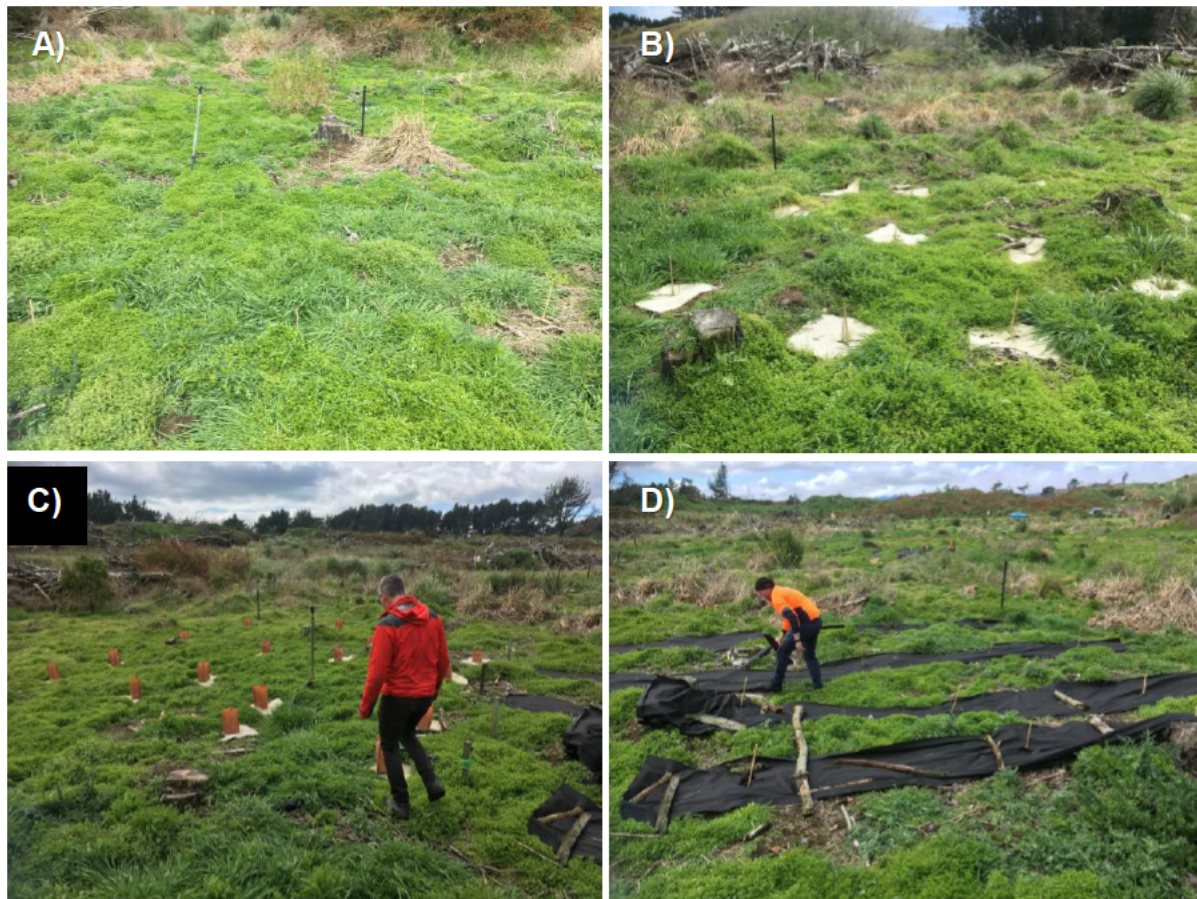
Figure 2 Weed management trial with four different treatments. A) no weed control; B) wool mulch mats; C) wool mulch mats and CombiGuards; D) black polypropylene weed mats.

To investigate alternative weed management options to improve plant survival, a trial was established in August 2020. A total of 192 mānuka seedlings were planted in three plots of 10 m x 10 m. The plots were arranged at equal distances from the sprinkler heads to ensure even TMW irrigation. Each plot was subdivided into four areas of different weed control treatments with 16 plants each (Figure 2); (a) no weed control, (b) wool mulch mats, (c) a combination of wool mulch mats and CombiGuards (polythene sheaths supported by bamboo stakes), and (d) black polypropylene weed mats. One-year old seedlings of mānuka were planted on 26th August 2020. After 12 weeks of growth, the height of each seedling was measured. Plant health was determined using a semi-quantitative visual assessment, rating plants from “1” (heavily chlorotic or necrotic) to “5” (healthy). If a plant had died, a “0” was assigned on the health index. Plants that could not be found were assumed to be dead and recorded as “0”. Survival rates were calculated for each treatment.

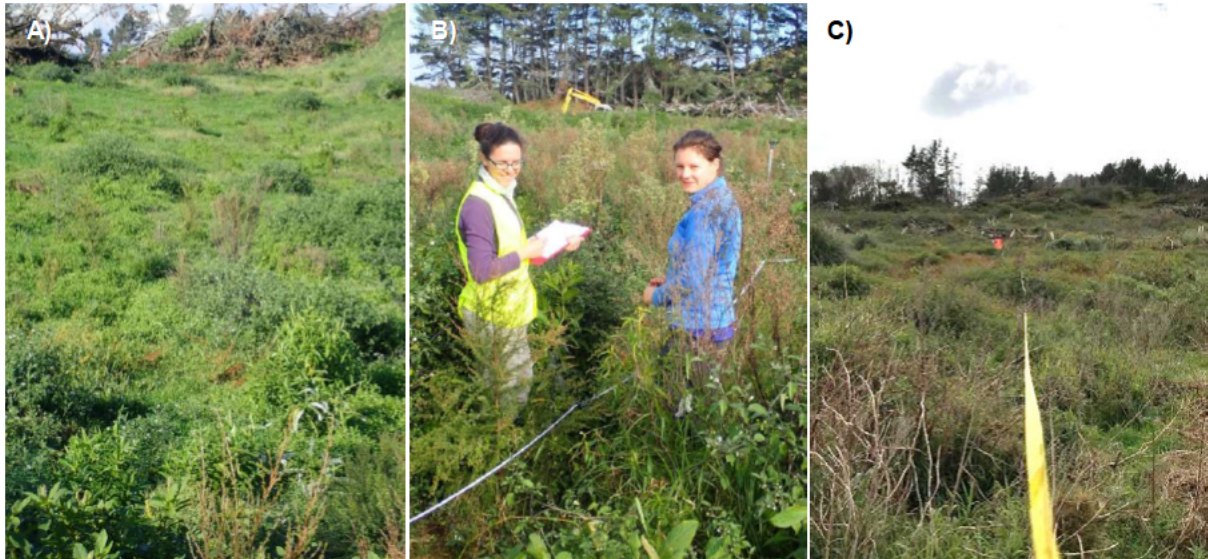
Figure 3 A) Area with irrigated natives planted into pasture in May 2019; B) area with visible weed management in May 2019; C) transect monitoring.

Plant survival, plant height, and weed cover were measured in May 2019, May 2021, and May 2022 using transects of 25 m² (12.5 m x 2 m) that were randomly chosen in different parts of the experimental area. Plants within 1 m from a 12.5 m tape were recorded and their height was measured with a measurement stick (Figure 3). The coverage of weeds was visually estimated based on a percentage of total ground area covered by each weed species.

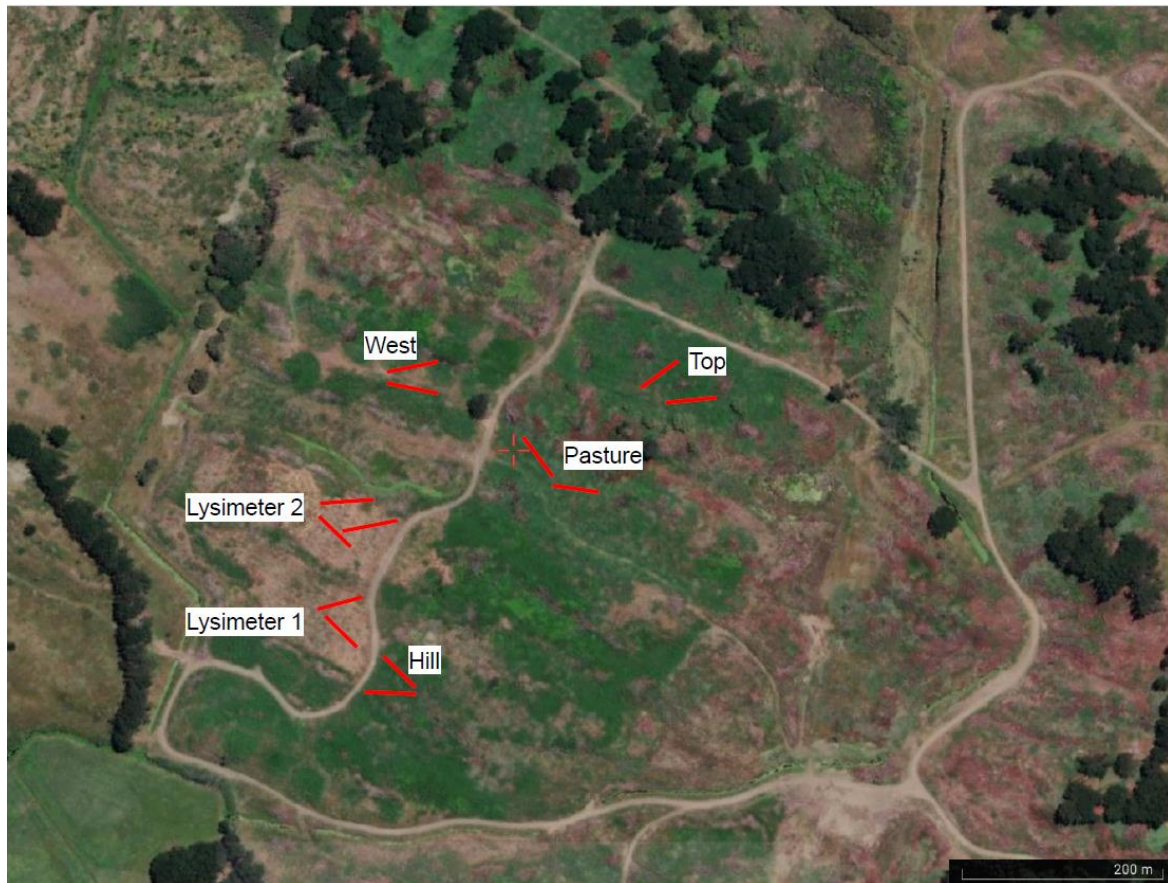
Figure 4 Location of transects recorded in May 2022 (red lines). The non-irrigated control area is next to the entrance and not shown here.

In May 2022, 60 transects were conducted, thereof 52 in six separate sections of the TMW-irrigated experimental area, and 8 outside of the experimental area in same-aged native vegetation without irrigation (Figure 4). In this monitoring campaign, the non-irrigated area sampled was located next to the main entrance gate to The Pot.

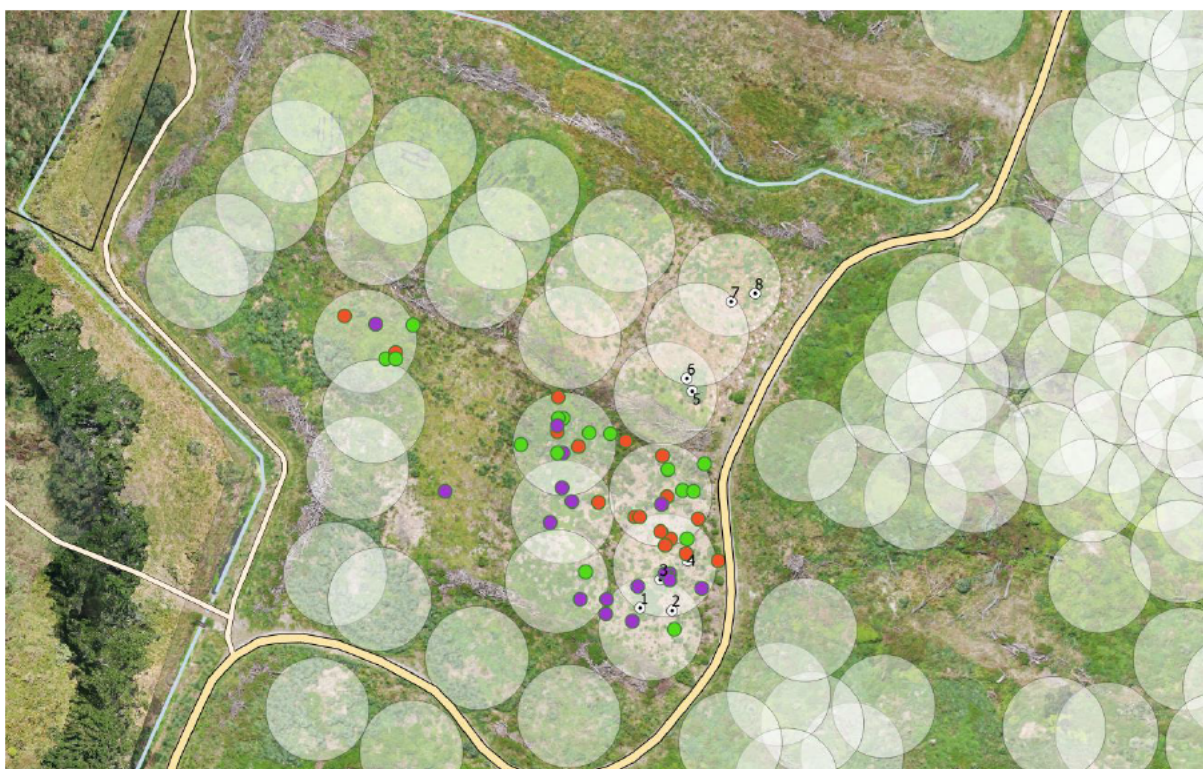
Figure 5 Aerial image showing the reach of the irrigation sprinklers in white circles, and sampling points in small red circles (mānuka), green circles (kānuka) and purple circles (pasture). Numbered points show the location of the Water Flux Meters (WFMs, Section 3.5).

In May 2019 eight Water Flux Meters (WFMs, Figure 8A) were installed in two TMW-irrigated flat areas at 10-20 m distance from the road. The exact locations are shown in Figure 5.

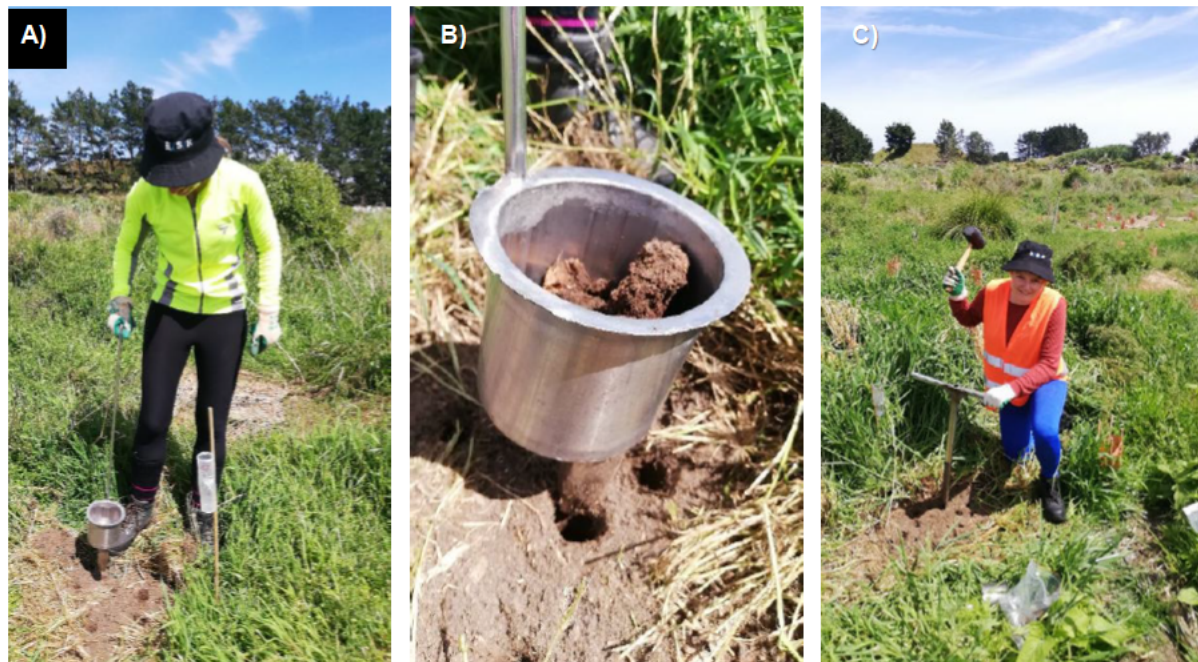
Figure 7 A) Collection of soil sample from the top soil (0-10 cm) with a bucket soil sampler; B) pooled sample in the bucket soil sampler; C) Collection of soil sample from the sub soil (30-45 cm) with a soil corer

Ten subsamples from the topsoil (0-10 cm) around the stem of each of the 17 mānuka and kānuka plants were collected with a bucket soil sampler and pooled into one sample (Figures 7A & B). A similar process was used to sample the topsoil under pasture cover in an area of approximately 0.25 m² after removing the vegetation cover. Soil from below the root systems (30-45 cm) was collected with a soil corer (Figure 7C) in the same areas where the topsoil was collected. Soil samples were transported to the laboratory in a chilly bin with icepacks and frozen at -20°C until further analysis.

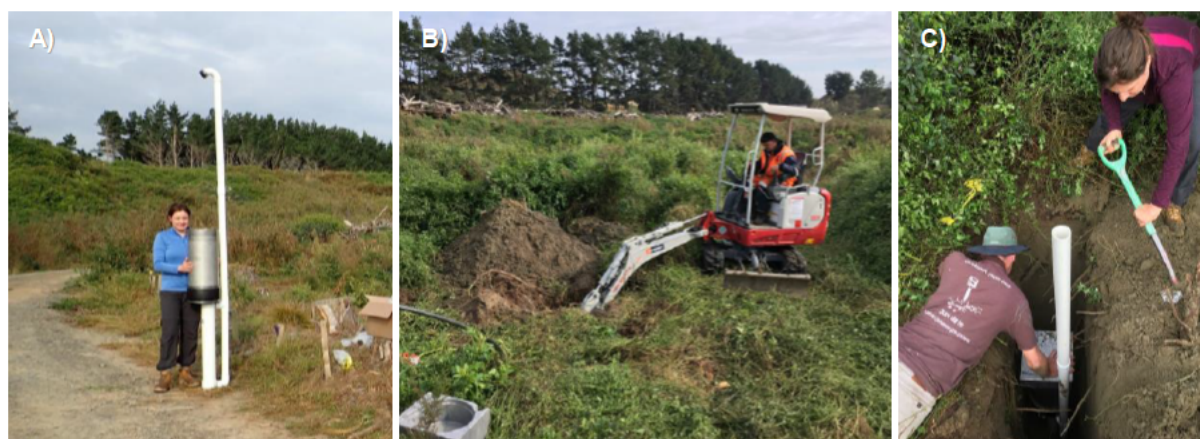
Figure 8 A) Water flux meter (WFM) ready for installation; B) Digging the trench for the installation of the WFM; C) installing the WFM.

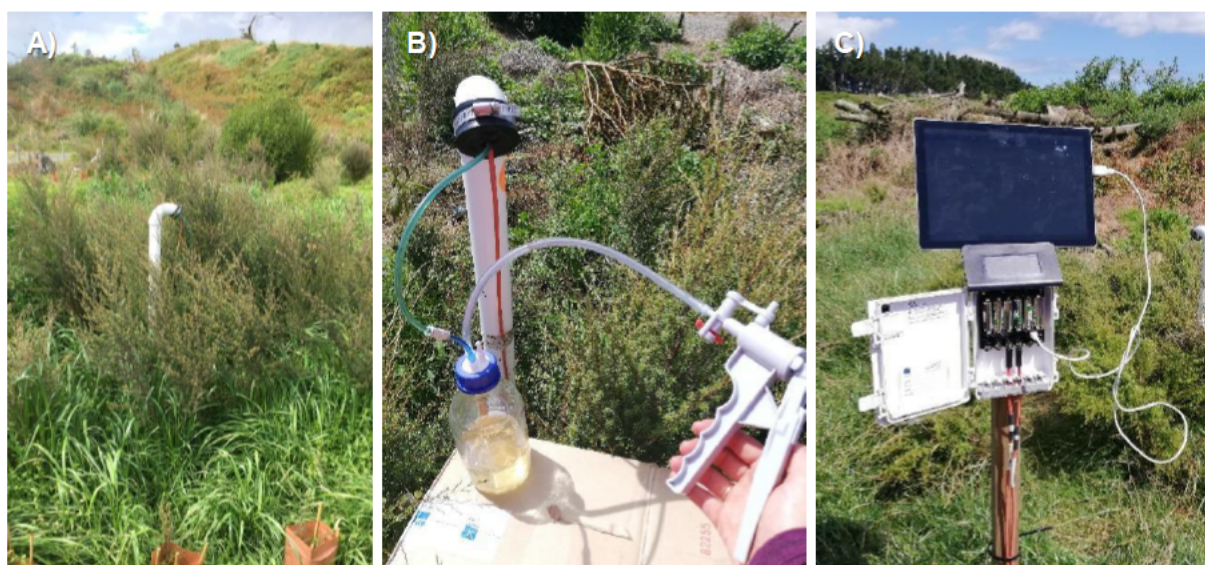
Figure 9 A) WFM with kānuka plants; B) Collecting leachate samples from the WFMs by handpump; C) Retrieving data from the data logger.

In August 2019, kānuka seedlings were densely planted (25 seedlings at 0.5 m spacing) on 2.5 x 2.5 m areas above four of the WFM (Figure 9A). The areas above the other four WFM was sown with a mixture of perennial ryegrass (*Lolium perenne*) and Yorkshire fog (*Holcus lanatus*). A similar seed mixture was applied around the kānuka seedlings and other areas of the experimental plots to prevent the germination of other weeds. The drainage in the WFM reservoirs was emptied by hand pump (Figure 9B). Four METER Environment® ZL6 data loggers were installed, and each was connected to two WFMs (Figure 9C). These data loggers allowed the collection of data on drainage volume, drainage electrical conductivity (EC), drainage temperature, and logger temperature.

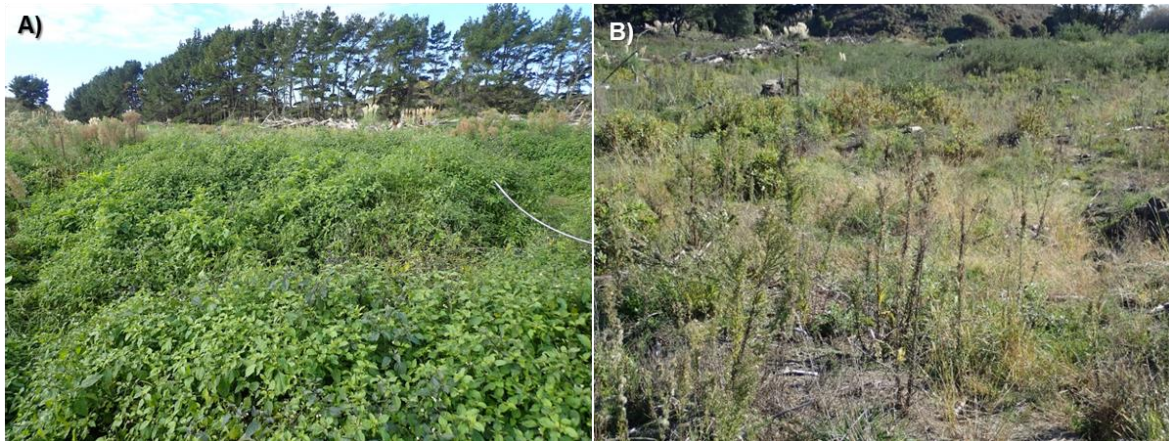
Figure 13 A) Overgrown part of the experimental plot; B) area planted in natives but non-irrigated, with fleabane.

During plant monitoring in May 2019 few natives were evident in the experimental plot due to the overgrowth of weeds (Figures 13A & B). Plant survival in the TMW irrigated plots with and without weed control was lower (27% and 2.2%, respectively) than in the non-irrigated plots (65%) (Figure 14A). Plant mortality in the non-irrigated treatment was comparable to other native restoration sites in NZ, where seedling mortality typically ranges from 11-38% in the first year (Anton et al., 2015). However, the lower plant survival in the TMW-irrigated areas was unlikely a direct consequence of irrigation, but rather a result of weed competition, which can significantly reduce native plant survival. There was an inverse relationship between native plant survival and weed coverage (Figure 14B). While other studies found belowground competition to be dominating interactions between invasive species and native seedlings (Costa et al., 2019), competition for water and nutrients is unlikely with irrigation of TMW. Instead, the effect of weeds on native plant survival likely resulted from the competition for light (Williams & West, 2000), as well as the high-humidity conditions created by TMW irrigation underneath a dense weed canopy.

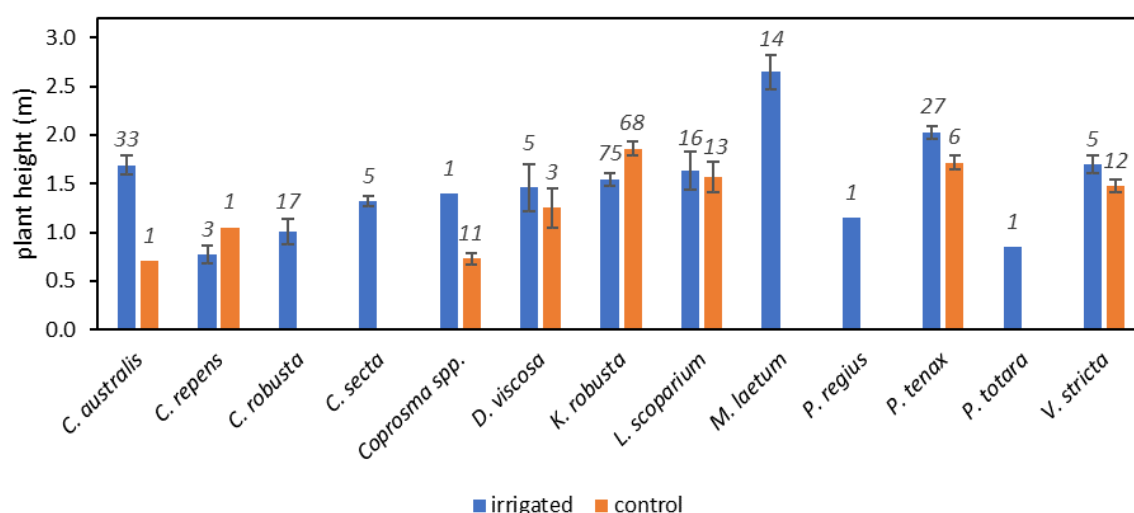
Figure 23 Plant height of NZ-native species in all irrigated transects combined, as well as in the non-irrigated control block next to the entrance. Mean ± standard error, with the italic number showing the number of plants recorded.

In the TMW-irrigated area, most of the native species significantly increased in height since 2021 (Figure 23). However, koromiko showed signs of chemical toxicity and did not increase in height. Similarly, akeake had brown lesions on the leaves, which could potentially indicate toxicity from TMW irrigation or spray drift (Figure 24). Karamu showed signs of animal browsing, with many specimens being defoliated, and did also not increase in height. With the exception of kānuka, plant heights in the control plots were the same or lower than in the TMW-irrigated plots. Therefore, over the four-year growing period, there is evidence that the TMW increased plant growth. This is consistent with another site where TMW irrigation accelerated the growth of New Zealand native vegetation (Meister et al., 2022). The most successful native species were New Zealand flax, ngaio, and cabbage tree.

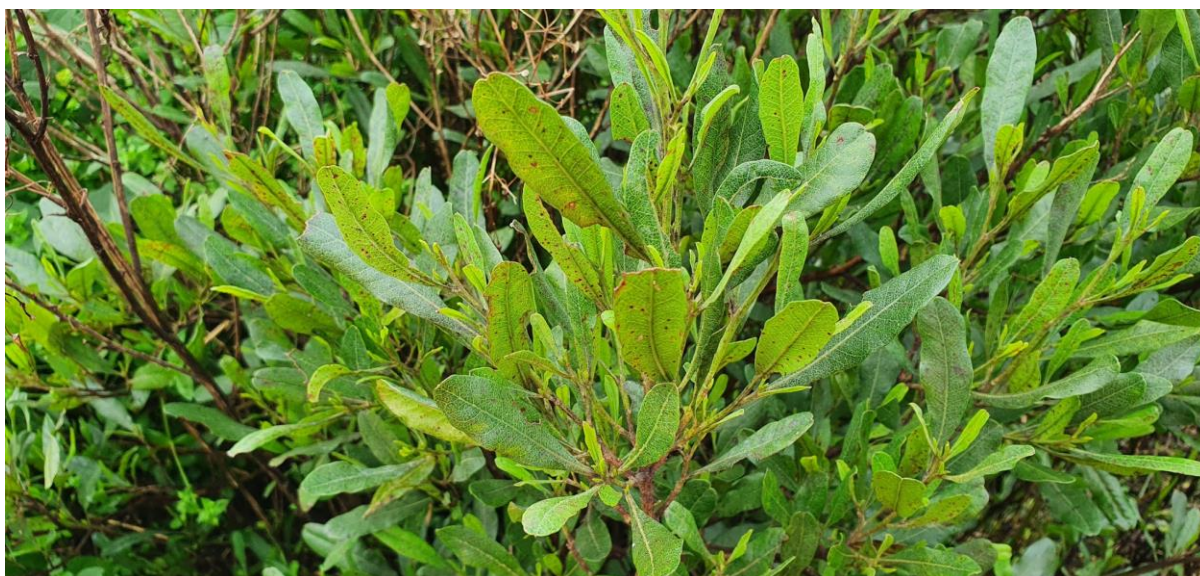
Figure 24 Evidence of toxicity in akeake.

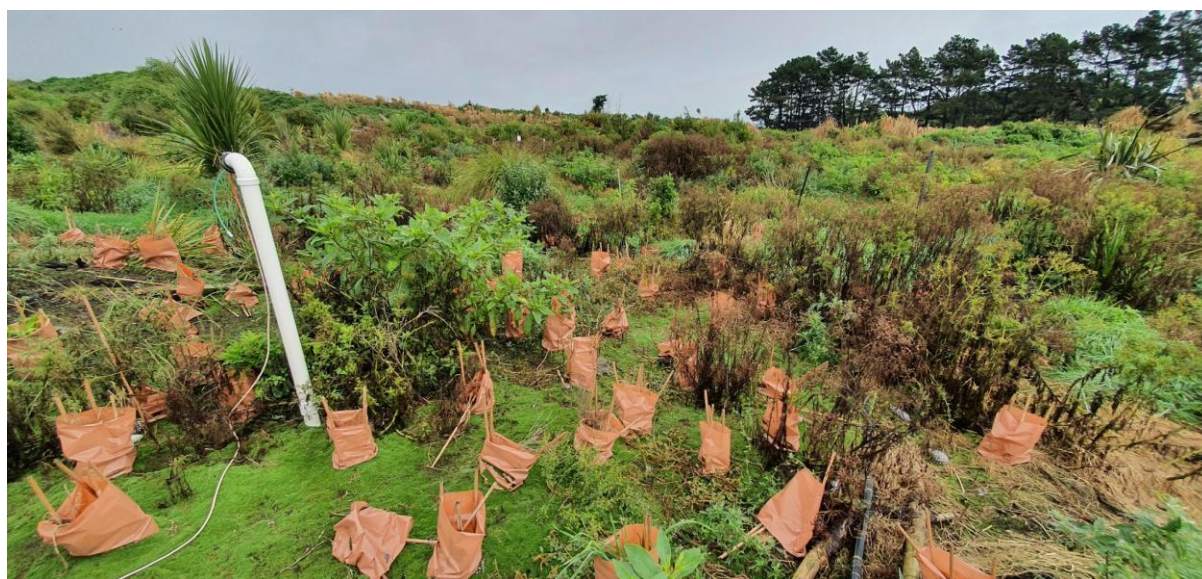
Figure 27: All kānuka and other higher plants on two of the lysimeters had died, leaving a cover of moss.

Samples from the sampling campaign conducted between November 2021 and January 2022 were sent for analysis of nitrate and ammonium. Generally, the mass of nitrate leached was small, representing about 2-20% of the mass of nitrogen applied. This was most likely due to groundwater ingress that led to a dilution of the leachate within the lysimeter, and possibly due to some denitrification. However, denitrification in TMW-irrigated soils was reported to contribute just 1% to N losses from TMW-irrigated soils (Van der Weerden et al., 2016). It was evident that the lysimeters had become flooded due to nearby surface ponding. There were no surviving kānuka on two of the lysimeters (Figure 27), and consequently no roots to impede infiltration. All higher plants at these sites were dead, presumably due to chemical toxicity arising from excessive TMW irrigation.

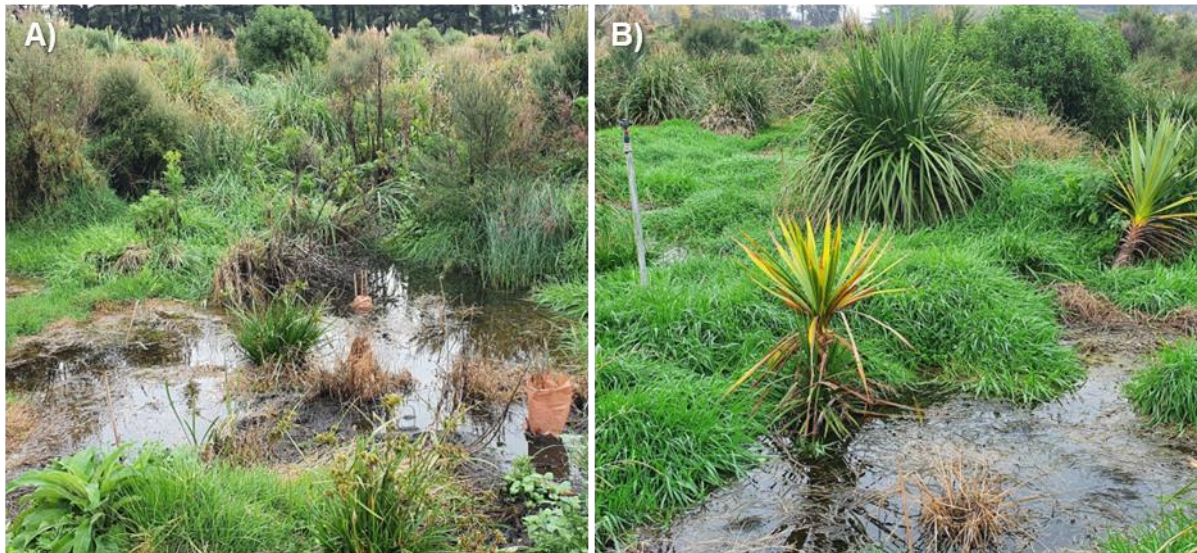
Figure 29 A) Standing water in the TMW-irrigated plots; B) cabbage trees starting to die off in May 2022.

The changes in the weed flora are consistent with observations of extremely wet conditions at the site. The fern species and pampas grasses mostly occur in wet conditions (Gosling et al., 2000; Lehmann et al., 2002). Standing water was present in various locations across the experimental plots at The Pot (Figure 29A & B). In many of these areas, all higher plants had died, including both weeds and NZ-native plants, which was a likely a consequence of either the waterlogged conditions which plants were not selected for, or chemical toxicity arising from high application rates of TMW (Figure 30A). Toxicity can derive from excess nutrients or increased sodicity and salinity, for example (Bernstein, 1975; Chaney, 1989). Some areas around the sprinklers were only covered in pasture and could not sustain other plant species (Figure 30B). In contrast, native plants were more present outside of the irrigated areas. In order to avoid further plant death, a reduction in TMW application will likely be required. It was demonstrated elsewhere that native vegetation can be established successfully with TMW irrigation of 1000 mm/yr (Meister et al., 2022). If this was achieved, native plantings at The Pot would be highly valuable as they provide ecosystem services, for example carbon sequestration and erosion control, provide a habitat for native insects and birds, and may be utilised for the production of fibre and timber (Gutierrez-Gines et al., 2022).

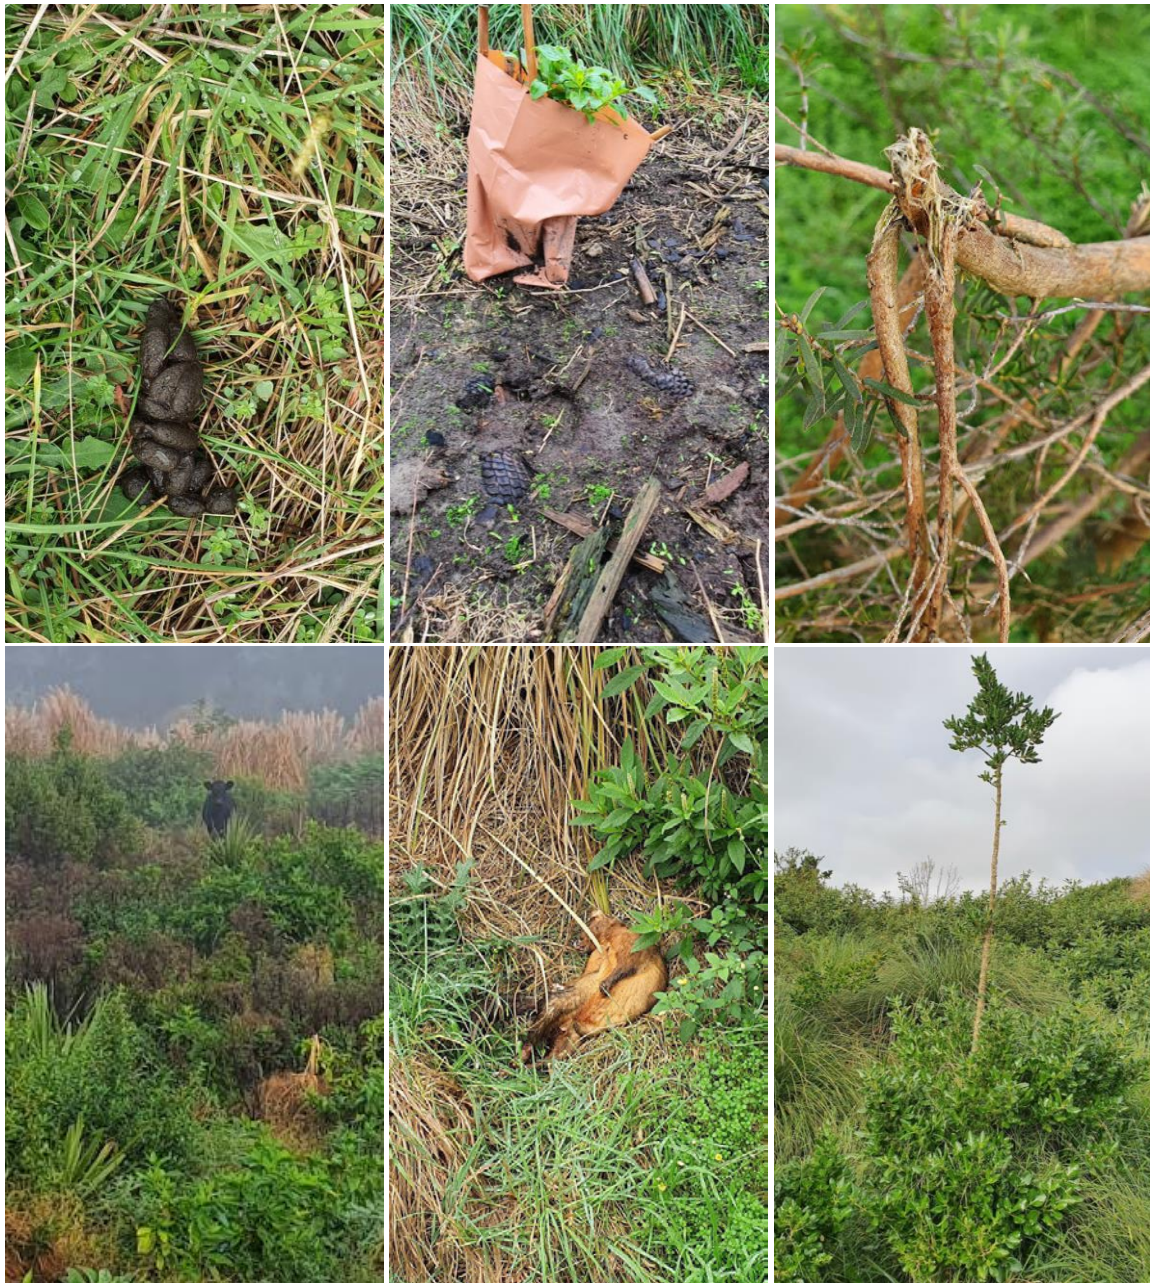
Figure 32 Evidence of animals browsing and damaging plants at The Pot.

Throughout the site, there was evidence of animals impairing plant growth in May 2022. Droppings of deer and cows were distributed throughout the plots, and a cow was spotted on site (Figure 32). In addition, snails were present at the site, which were also observed in 2021. We observed plant damage that was consistent with animal browsing and scratching, including defoliation and broken branches (Figure 33). Fencing and lethal methods of pest control, including shooting and poisoning, may be required to control pests at the site. Where large populations of mammal pests are present, this can lead to the disappearance of palatable, typically large-leaved, species from native plantings (Bee et al., 2007; Smale et al., 1995). This is supported by observations at The Pot, where many *Coprosma* spp. appeared to be defoliated due to browsing (Figure 33).
