# Foxton Wharf: Options Assessment

Prepared for Horowhenua District Council Prepared by Tonkin & Taylor Ltd Date September 2019 Job Number 1007760.v1

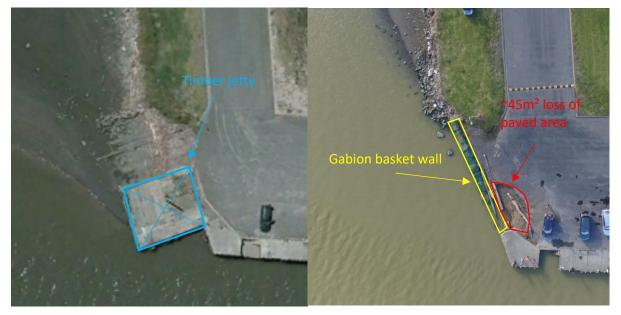
Figure 2.1: Aerial showing historic timber jetty prior to removal (left; January 2010, Google Earth) and erosion at the western corner of Foxton Wharf (right; July 2018, T+T)

Erosion at the western corner of Foxton Wharf resulting from waves and currents has resulted in loss of approximately 45m<sup>2</sup> of paved area adjacent (refer Figure right). This erosion has followed the removal of a timber jetty and replacement with a gabion basket wall along the seaward edge of the wharf area in 2014 (refer Figure right).

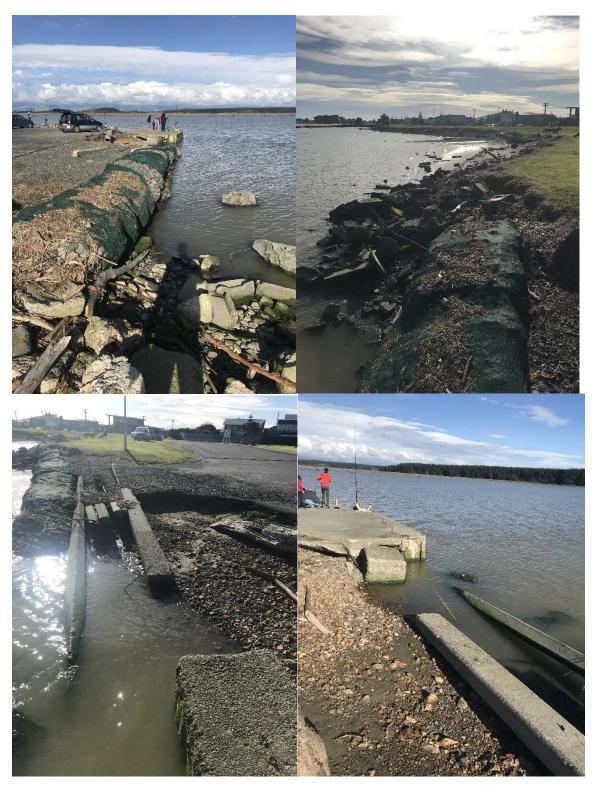
*Figure 2.2: Site photographs taken on 19 July 2018 showing the degraded gabion basket wall (upper photographs) and the eroded wharf area (lower photographs)*

The gabion basket wall was installed as a temporary measure to protect the exposed reclamation edge following removal of the timber jetty. The gabion basket wall has since degraded, the wire mesh has corroded in places resulting in loss of rock and the structure has been undermined leading to slumping at the southern end. The slumping of the wall has allowed greater volumes, and higher frequency, of wave overtopping to occur at this location leading to erosion of the pavement and reclamation fill. Figure 2.2 shows site photographs (19 July 2018) of the degraded gabion basket wall and eroded wharf area.

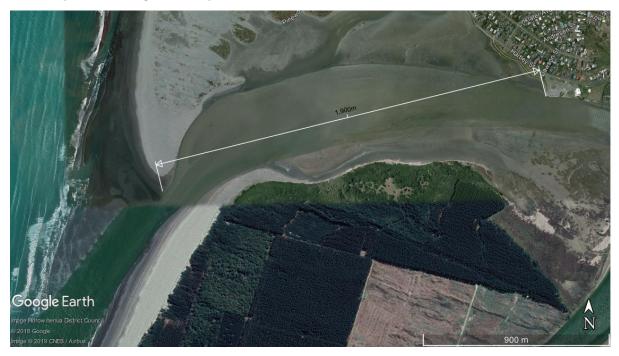
Figure 3.3: Maximum fetch distance at Foxton Wharf site

The site is exposed to wind waves from the westerly quadrant with a maximum fetch length of 1.9 km to the west south-west (refer Figure 3.3). The height of wind-generated waves is dependent on water depth, fetch length, wind speed and duration.

Waves generated by wind from the west with a 1% AEP were assessed based on regional wind speeds outlined in AS/NZS1170.2:2011 and the Goda (2003) method for calculating wave heights. Table 3.4 shows the resultant wind-wave height (mean wave height of the highest one third of the waves) offshore of the seawall. The shallow foreshore along the northerly portion of the site is expected to result in wave breaking reducing wave heights as they approach the shoreline. However, the water depth increases rapidly towards the southern corner of the site and therefore the waves are unlikely to be depth limited at this location. These wave heights have been used for design and are outlined in Table 3.4.
