Horowhenua District Council Building SH1, Levin - Seismic Assessment

**New Council
Building
126-148 Oxford St,
Levin**

Detailed Seismic Assessment Report

Date: 20th June 2014

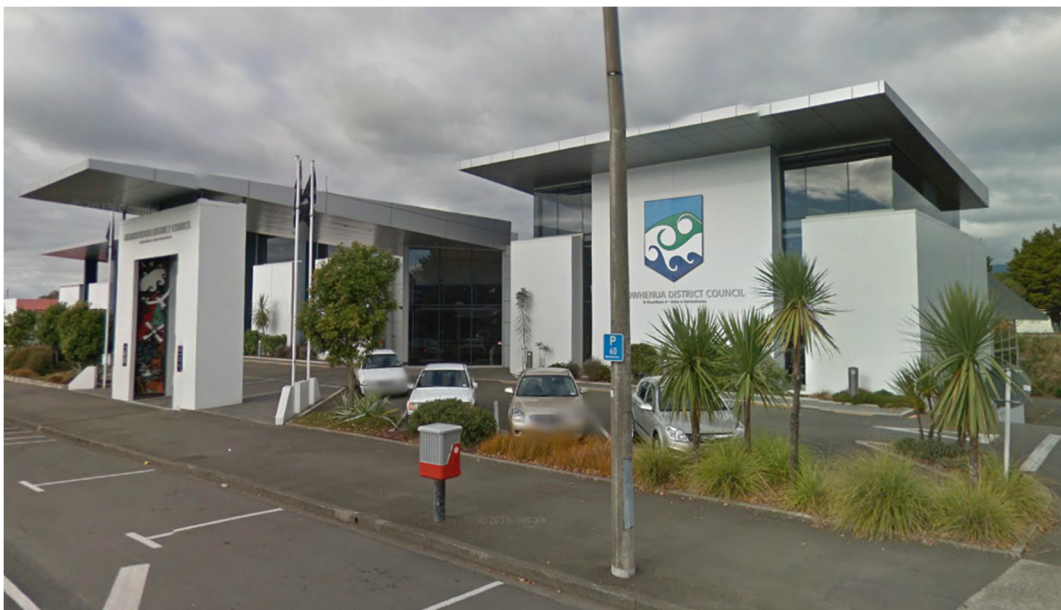
Figure 2: New HDC Council Building in Levin viewed from Oxford Street

A non-intrusive inspection of the building was completed and it showed that it is visually in good condition and generally accordance with the layout shown on the drawings sourced.
