Reference Number: 2023/995

### Response - Official Information Request

## **HDC – Foxton Memorial Hall - Initial Seismic Review.**

# **Foxton Memorial Hall Concept Seismic Retrofit Scheme**

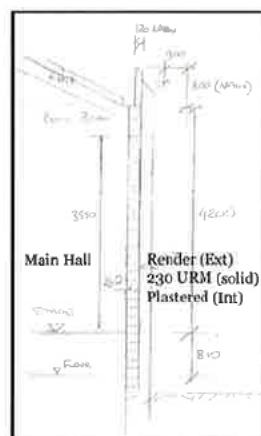
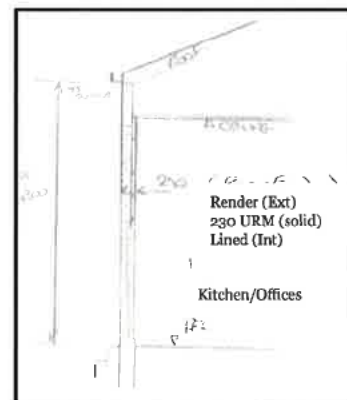
Fig 3. Sections through external walls.

The external URM panels were confirmed (by drilling) to be 230mm thick masonry with no cavity, plastered internally and with cement render externally (255mm overall thickness).

The foundation type could not be confirmed during the visual inspection however it is likely that the URM walls and concrete piers were built off the ground bearing foundations with thickenings/pads provided at the pier locations.

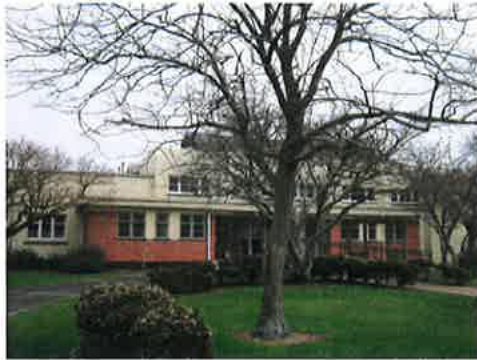
Fig 4. External View.

Generally the visible parts of the structure would appear to be in good condition for the age of the building with no obvious signs of movement or distress identified. However due to a recent refurbishment and redecoration having been undertaken on the building any existing cracking/movement would likely have been filled and painted over, both internally (plastered finish) and externally (rendered finish).

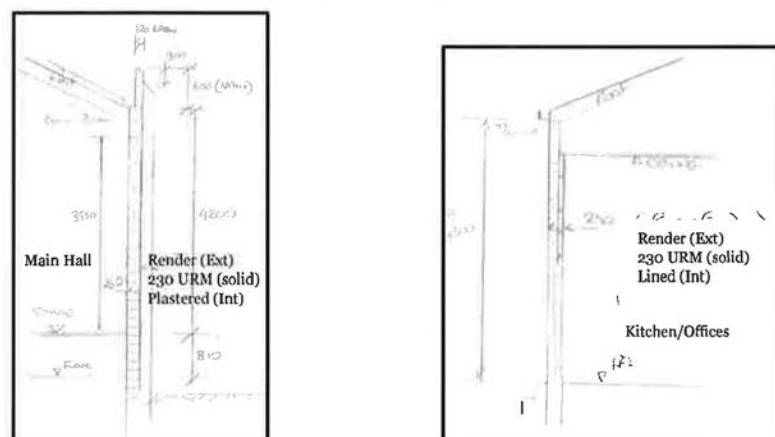
Fig 3. Sections through external walls.

The external URM panels were confirmed (by drilling) to be 230mm thick masonry with no cavity, plastered internally and with cement render externally (255mm overall thickness).

The foundation type could not be confirmed during the visual inspection however it is likely that the URM walls and concrete piers were built off the ground bearing foundations with thickenings/pads provided at the pier locations.

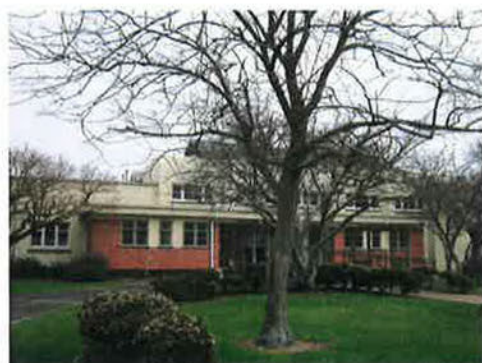
Fig 4. External View.

Generally the visible parts of the structure would appear to be in good condition for the age of the building with no obvious signs of movement or distress identified. However due to a recent refurbishment and redecoration having been undertaken on the building any existing cracking/movement would likely have been filled and painted over, both internally (plastered finish) and externally (rendered finish).
